**Figure 2. Imperial Oil Weir Site.** The demand for water to run a steam generated electrical plant resulted in the construction of a weir in 1960 (Hodgson pers comm. 2006). The weir was built at the site of an existing bridge (below) near the Mackenzie River. The pond that was created behind the weir provided Imperial Oil with water for power and the Town of Norman Wells with drinking water. The weir was removed in the summer of 2005 by Imperial Oil who undertook extensive restoration.

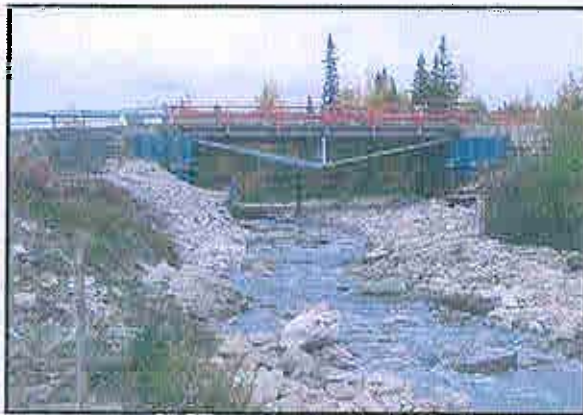
The weir at the lower bridge (above) before 2005. Photo courtesy of Imperial Oil Resources Limited.

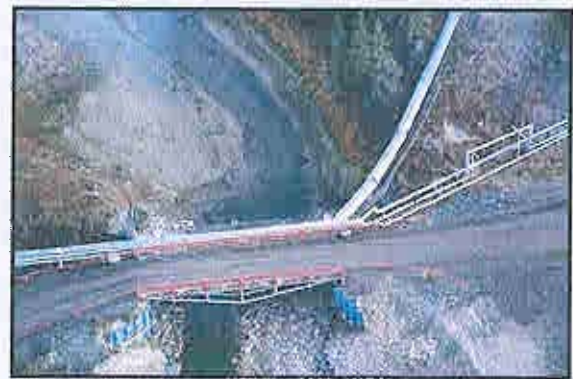
The lower bridge following removal of the weir in 2005 (above). Successful restoration of downstream habitat. Photo courtesy of Imperial Oil Resources Ltd.

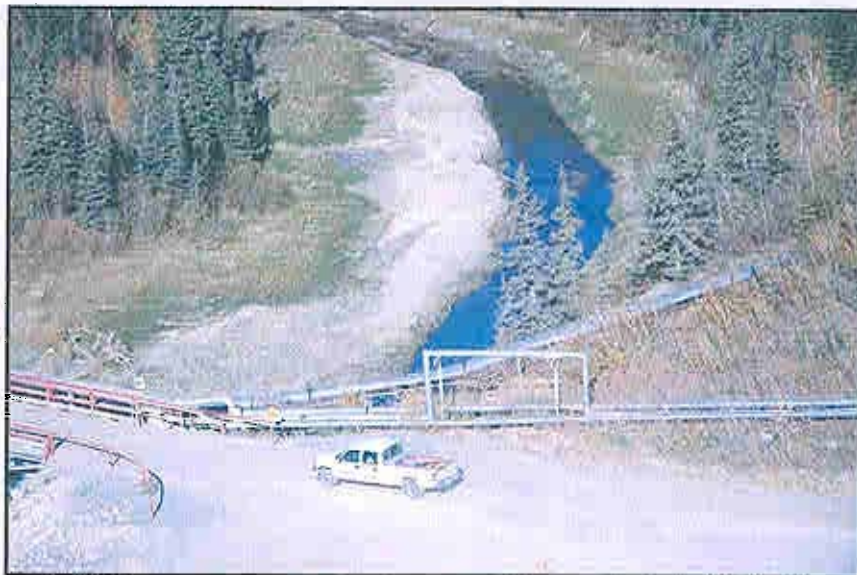
The lower bridge (above) after removal of the weir.

The weir impeded the natural flow of water and created a pond upstream. This led to an accumulation of silty sand that would have normally been transported into the Mackenzie River. Removal of the weir has re-established natural flow. The gray sediments (left) are the remains of the accumulated material. These deposits are a source of concern as rapid erosion may impact habitat downstream.
